# Building Inspection Report

**Prepared For:**  
Actual Inspection-Sample Report

**Prepared By:**  
Mason County Health Department  
1002 East Laurel Ave.  
Havana, IL 62644

**Report Number:**  
20110828

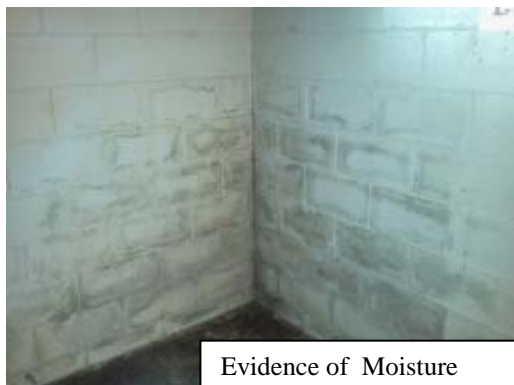
Evidence of Moisture

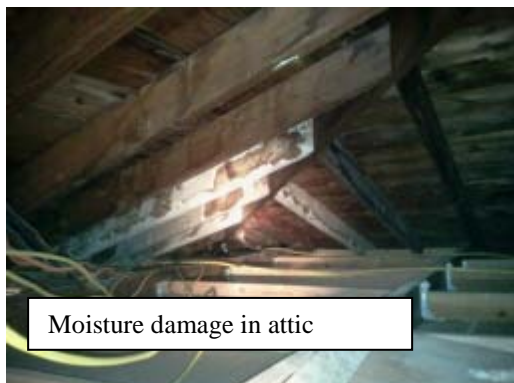
Moisture damage in attic

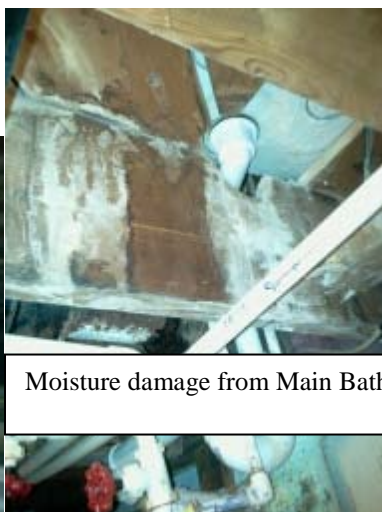
Moisture damage from Main Bath

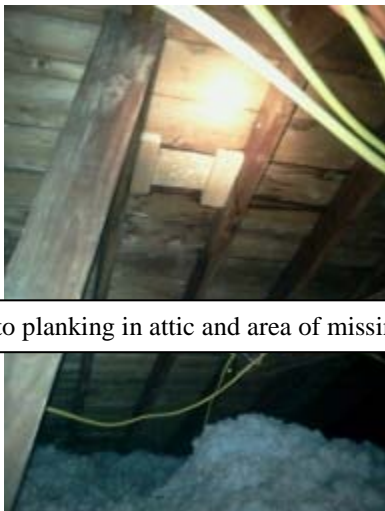
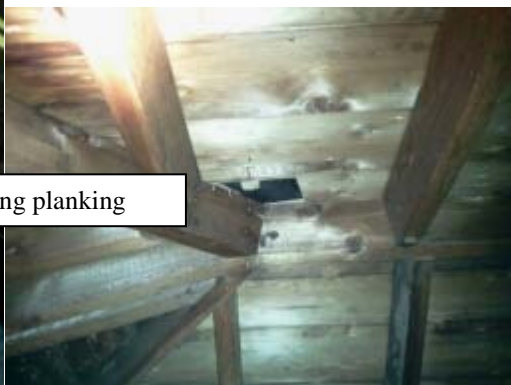
- **Monitor:** Prior repairs to the roof sheathing are evident- One small area missing planking and another small area had been repaired. No evidence of current leaking.

Repair to planking in attic and area of missing planking

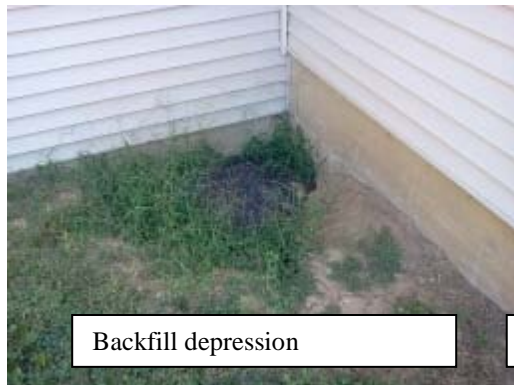
Backfill recommended in west corner to avoid water pooling.

Backfill depression

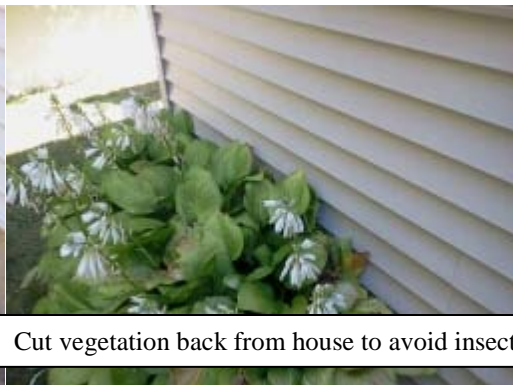
Cut vegetation back from house to avoid insects

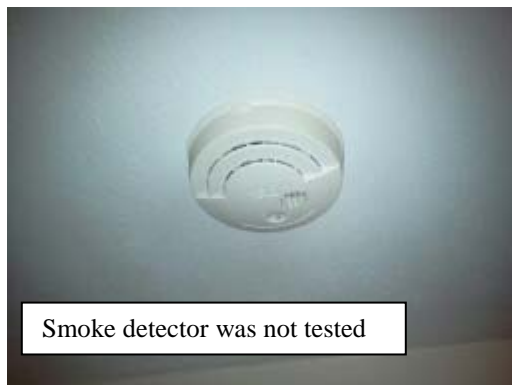
- **Repair, Safety Issue:** The smoke detector(s) was missing the testing button so was not tested.

Smoke detector was not tested

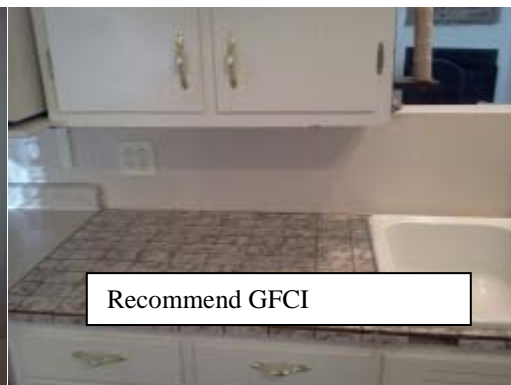
- **Safety Issue:** The installation of a ground fault circuit interrupter (GFCI) in the kitchen is recommended. A GFCI offers increased protection from shock or electrocution.

Recommend GFCI

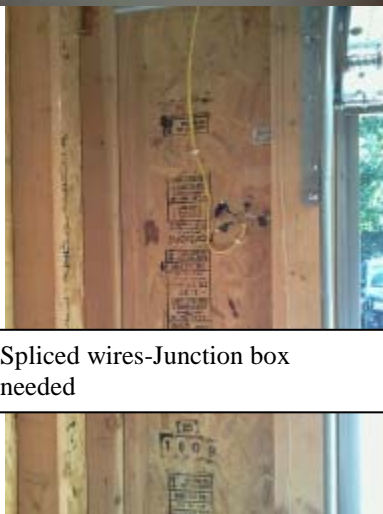
Spliced wires-Junction box needed

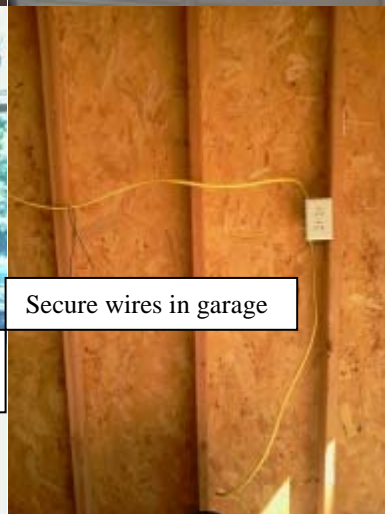
Secure wires in garage

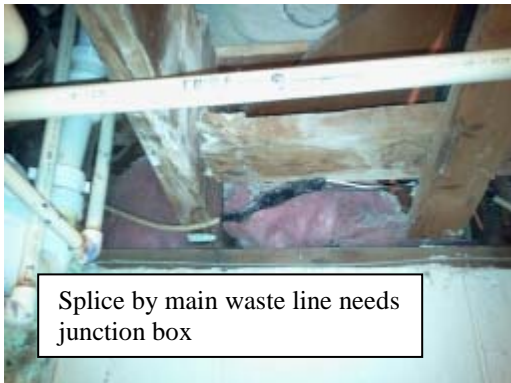
Splice by main waste line needs junction box

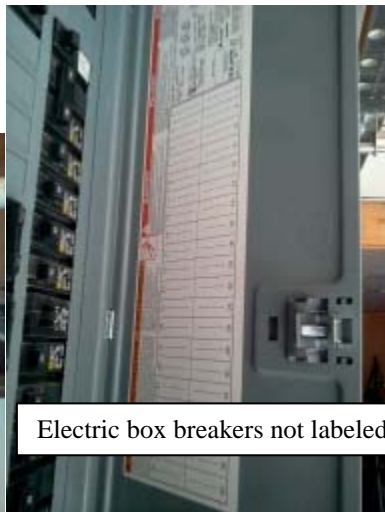
Electric box breakers not labeled

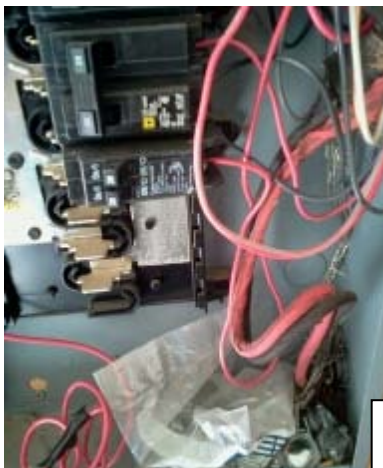
Recommend not storing parts in main panel

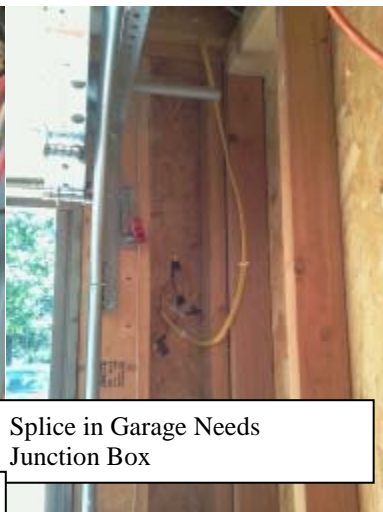
Splice in Garage Needs Junction Box

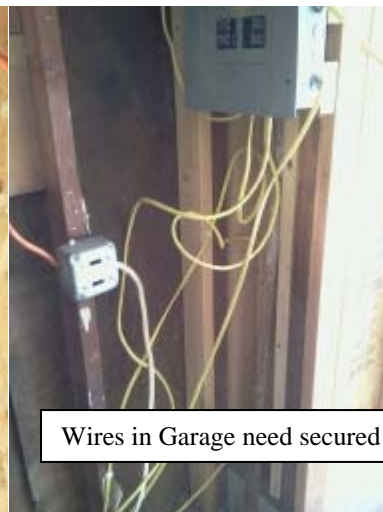
Wires in Garage need secured

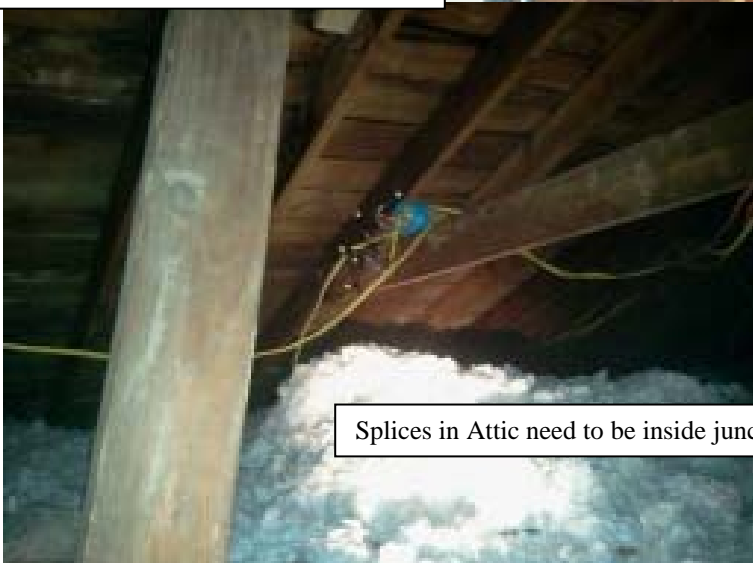
Splices in Attic need to be inside junction box

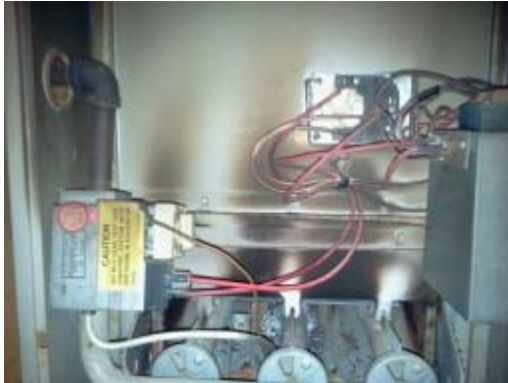
- **Repair, Safety Issue:** The heating system shows evidence of “flashback” (ignited gas spilling out at the front of the furnace at start up). This condition should be evaluated by a qualified licensed heating technician.

Flame rollout on start up(scorch marks). This is a potential safety issue and should be evaluated by a qualified contractor

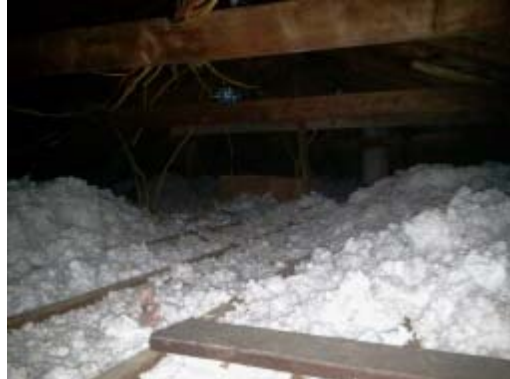
Recommend redistributing insulation in attic

- **Repair:** Disturbed insulation should be repaired or evened out.

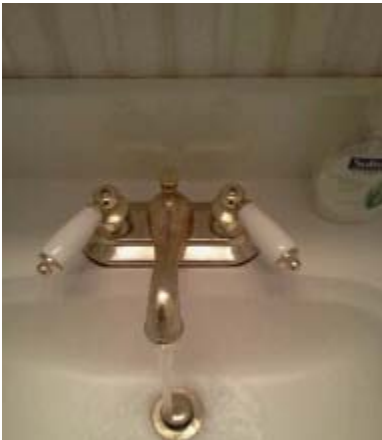
MB- drain plug does not operate

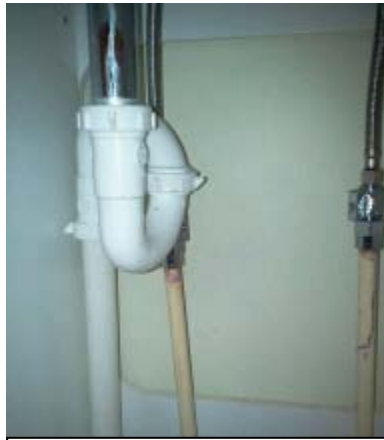
- **Monitor:** An "S" trap has been used. S traps should be replaced during any new plumbing work as they are subject to siphoning problems. Replacement is sometimes difficult and thus the S traps are usually tolerated. Care should be taken to keep the trap "primed". Fixtures should be monitored for sewer odor.

S-traps

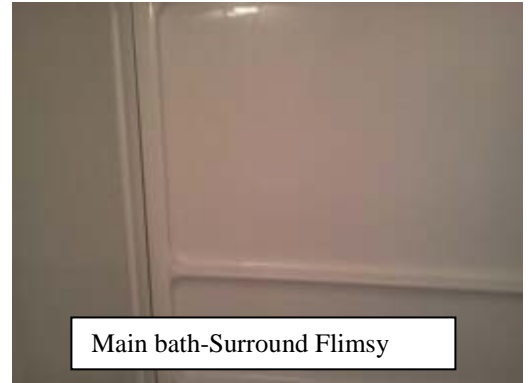
Main bath-Surround Flimsy

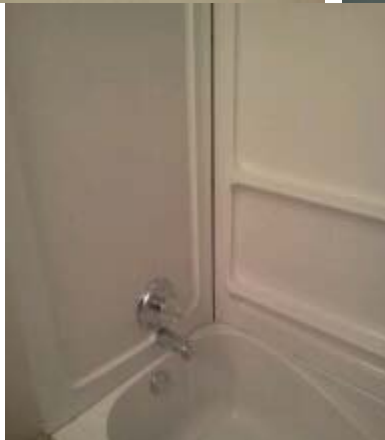
Main bath-faucet shutoff reversed

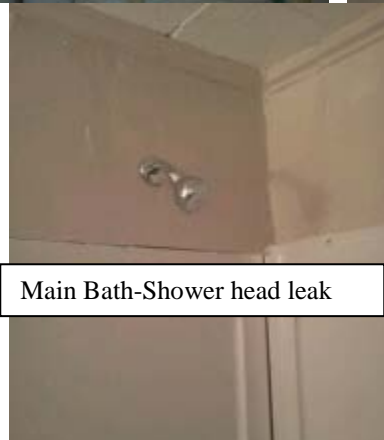
Main Bath-Shower head leak

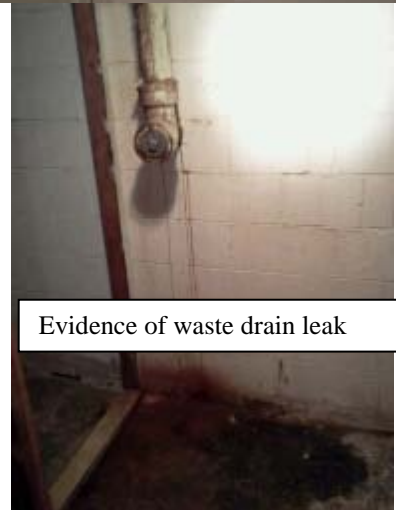
Evidence of waste drain leak

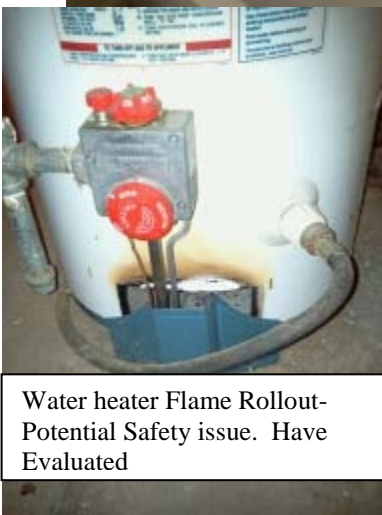
Water heater Flame Rollout-  
Potential Safety issue. Have  
Evaluated

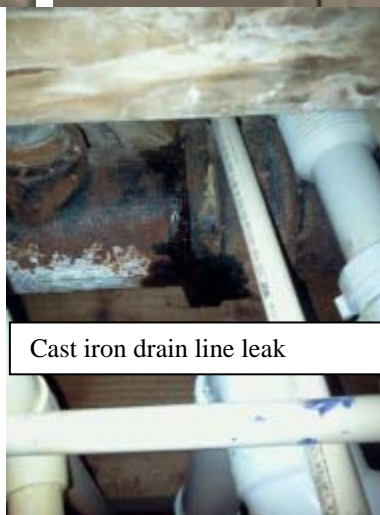
Cast iron drain line leak

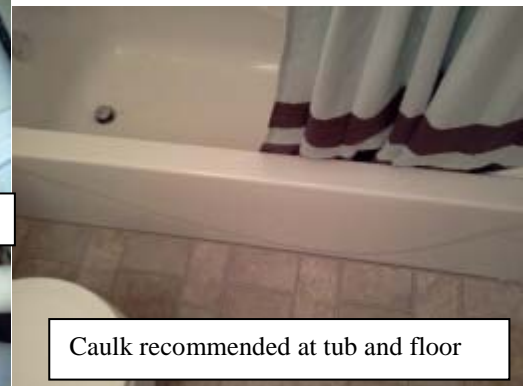
Caulk recommended at tub and floor

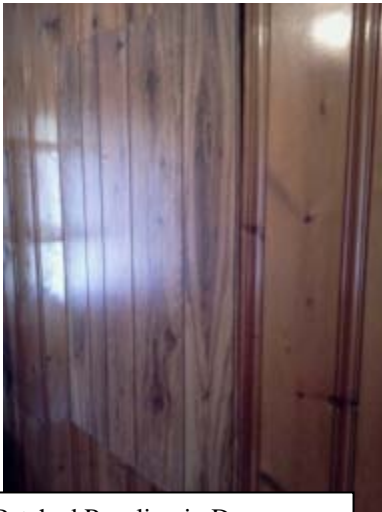
Patched Paneling in Den area
